KIT CARSON HOUSE

Taos, New Mexico

CURRENT CONDITION ASSESSMENT & PRESERVATION PLAN

Draft – September 16, 2022

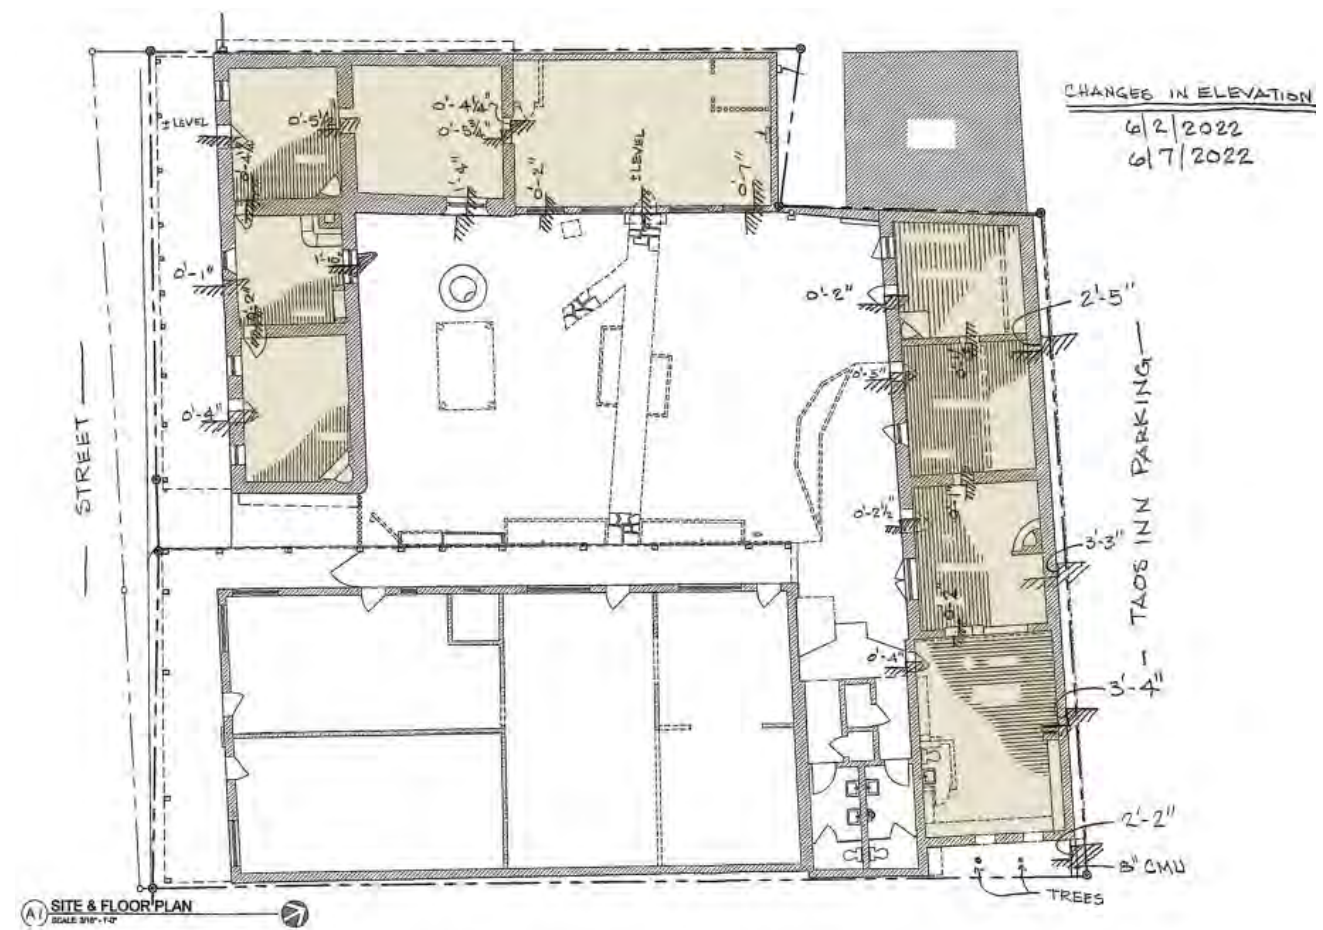
We found significant drainage issues in the central courtyard and around the perimeter of the buildings. In a number of areas, the exterior finish grade is higher than the interior finish floor.

There is considerable basal deterioration, with water not draining away from the walls. Also a concrete contra pared installed along the north side of Romero House is trapping water against the wall. Trees and other vegetation growing near structures are adding to the issues.

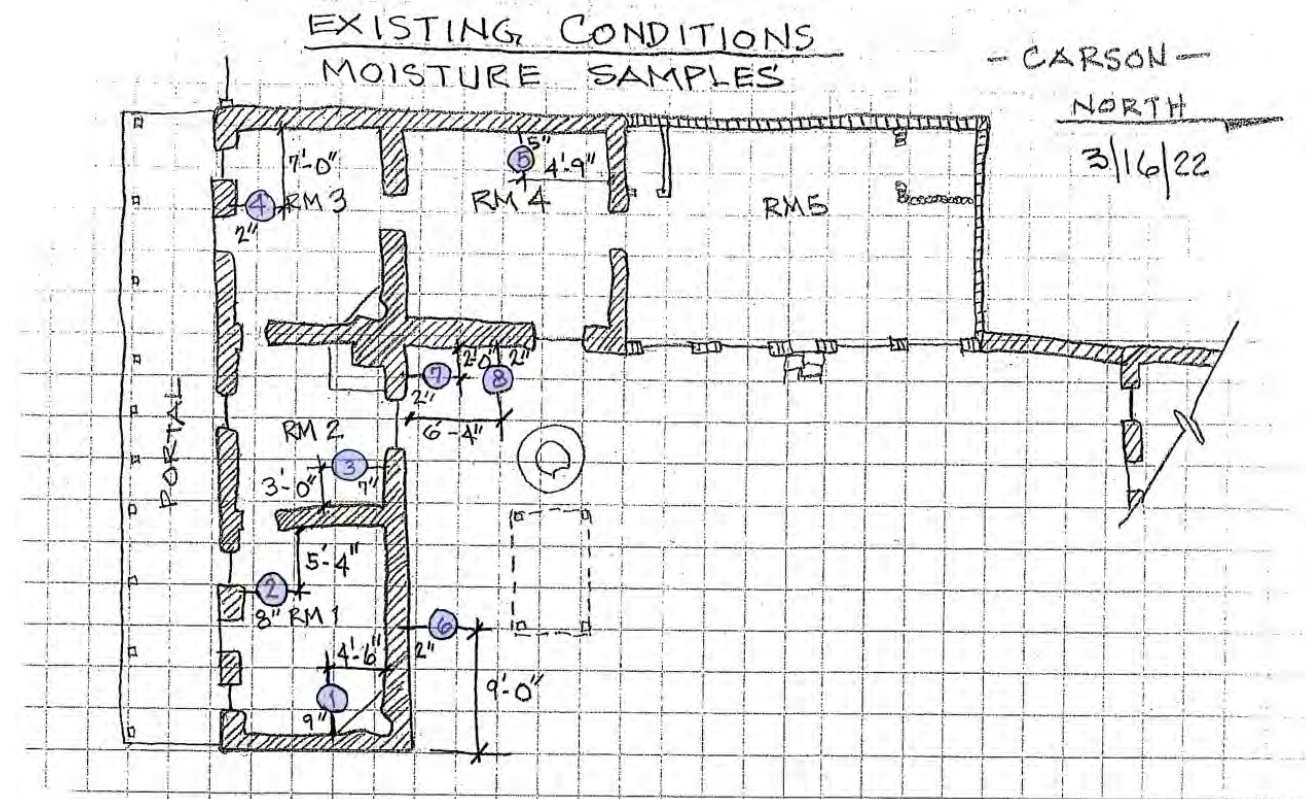
- Samples were not taken in Room 5 of Carson because the walls there are CMU.
- At Sample #5 the coring bit was rejected approximately 2" in to the wall and the sample could not be completed.

Above, locations of moisture samples taken at Carson House.

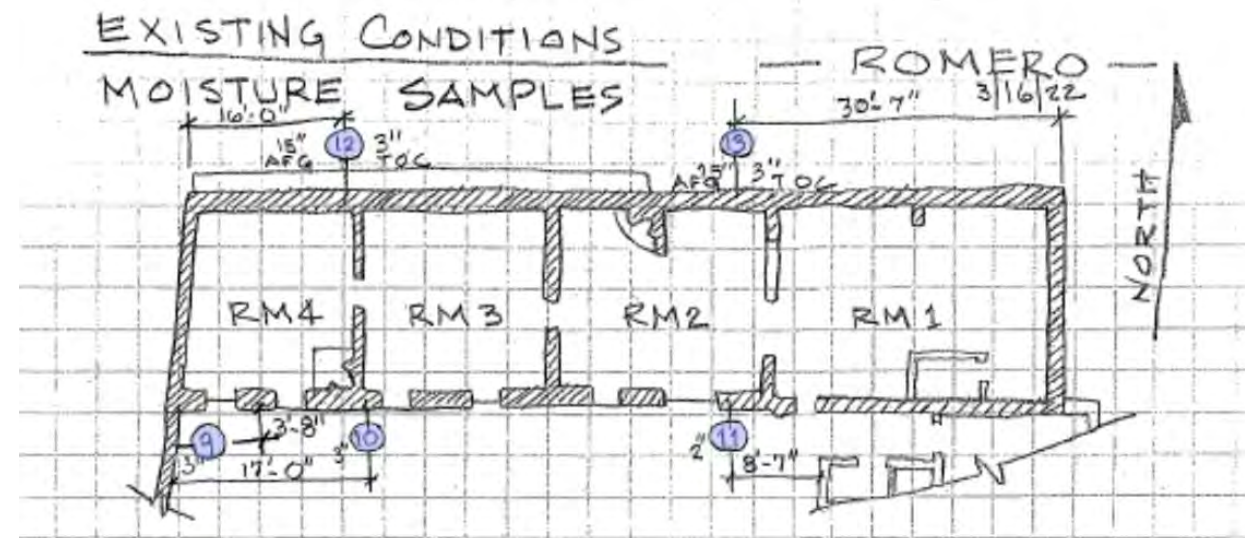
Below, locations of moisture samples taken at Romero House.

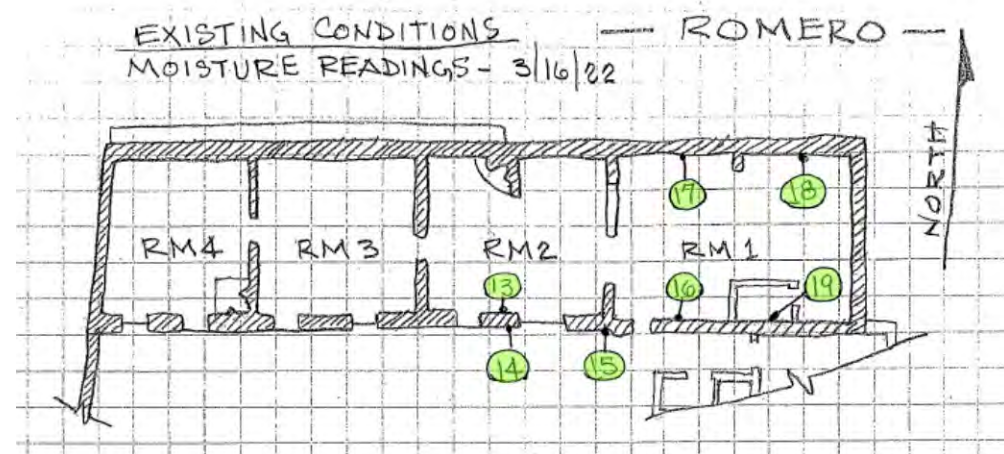
ROMERO HOUSE READINGS

The readings in Romero house tell a more desperate story about moisture levels in the walls at this building. Readings are high at all interior walls measured, from the bottom to the top.

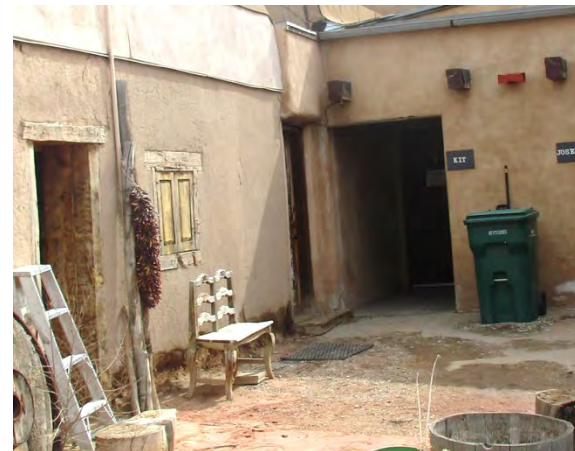
The Romero House wall by the bench on the left in this photo, the site of core sample #11, is constantly wet, consistent with site drainage issues noted in this area.

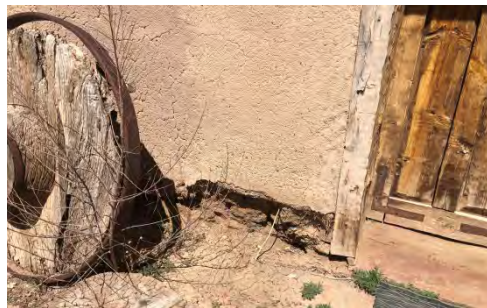
In the photo above, this courtyard image shows characteristic deterioration of walls at base on Romero House. At right, a view of the courtyard wall of Carson House, showing generally poor condition of exterior finishes and deterioration at base of wall.

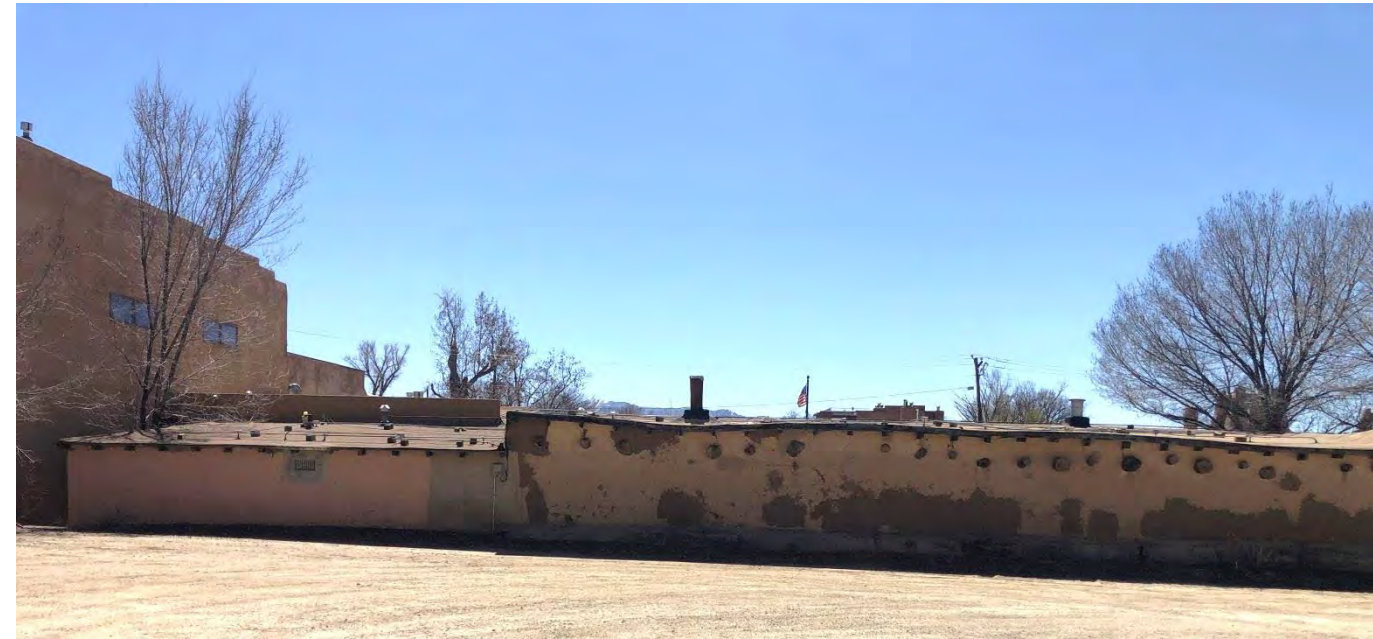
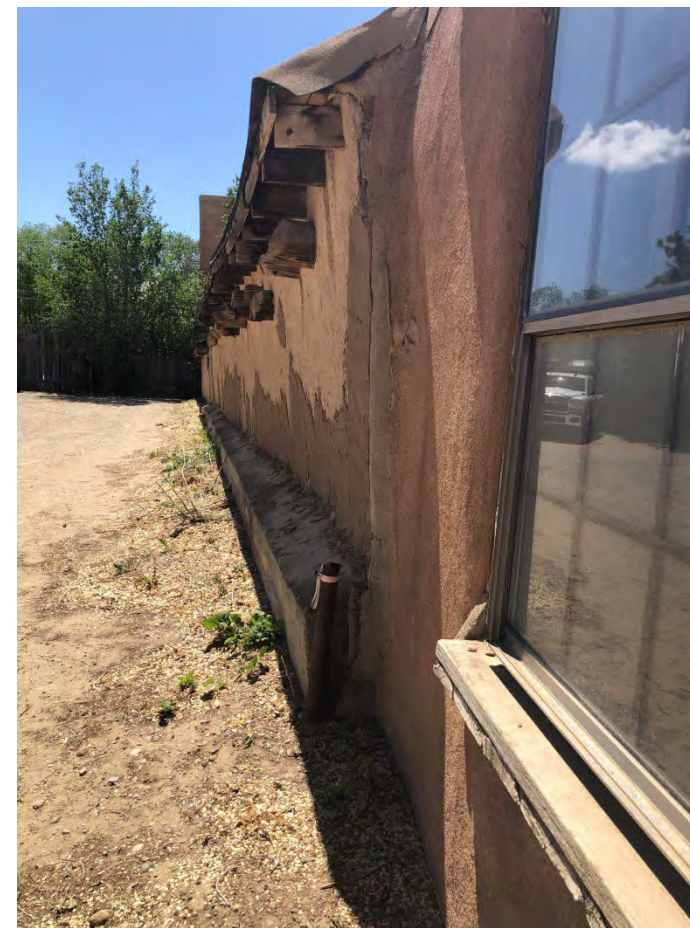
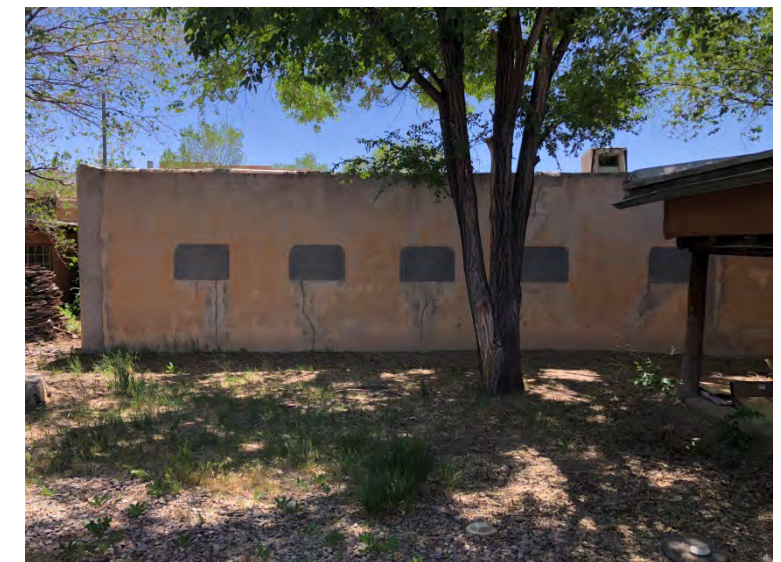
- Exterior finish is a combination of mud plaster and cement stucco, all in poor condition.
- Stucco has been more recently renewed at north side of Room 1.
- Wall along the rest of the north side of Romero House is mud plaster with some recent repairs at the visible base. Some of the wall is covered up by the concrete contra pared, which is likely to be trapping moisture within the base of the wall.
- West wall shows the in-filled windows and cracking.

The photo above shows the north wall of Romero House. At left, a closer look at the mud plaster portion of the north wall, with the contra pared. Below, a look at the west wall of Romero House.

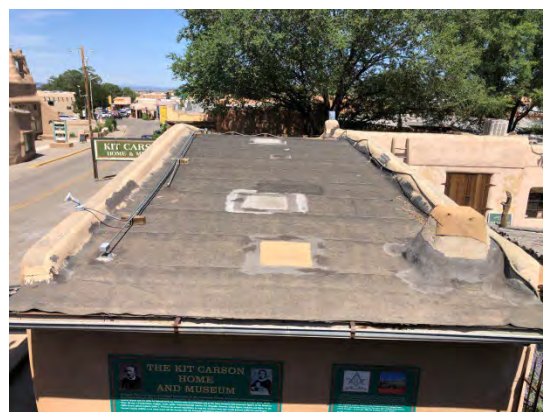
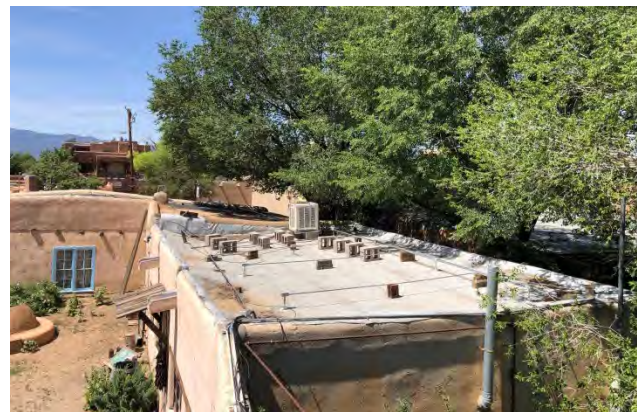
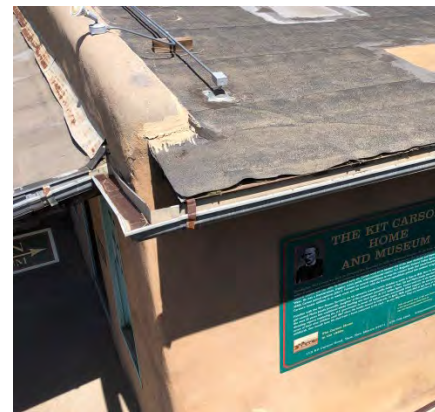
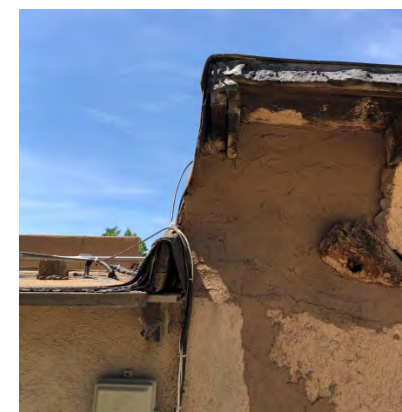
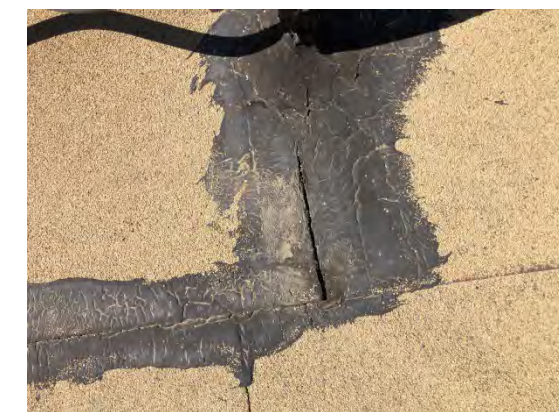
At the Carson House, the top layer roof is reported to be 27+/- years old, while the top layer at **parts** of the Romero House is reported to be 35 years old, though some new material installation **appears to** have been completed at the time the dirt was removed in 2005. At both houses, the roofing is past serviceable life, and must be removed and replaced. The Carson House gutters must be replaced. Romero House will need new gutters.

These aging roof systems, comprised of several generations of materials and construction in varying and largely unknown condition, no longer serve their structures reliably and certainly promote the risk of moisture entering both buildings. This report identifies the roof work as one of the highest priorities.

*Above right, field sketches of the existing roof installations at both buildings.
Below, photos show the diverse conditions of the aging roofs at both buildings. First three images are of Carson House.
Remaining two are at Romero House.*

This will involve removing all existing layers of roofing materials including the original dirt roof, which will immediately relieve the burden on the vigas, some of which are historic. Reconstruction of the roof will include structural repairs, and installation of empty conduits, ductwork, and other items in the roof cavity to minimize future disturbance within the roof during later phases of work on the buildings. Then a new roof system that is appropriate to the historic structure and that can protect the historic vigas and building below will be installed.

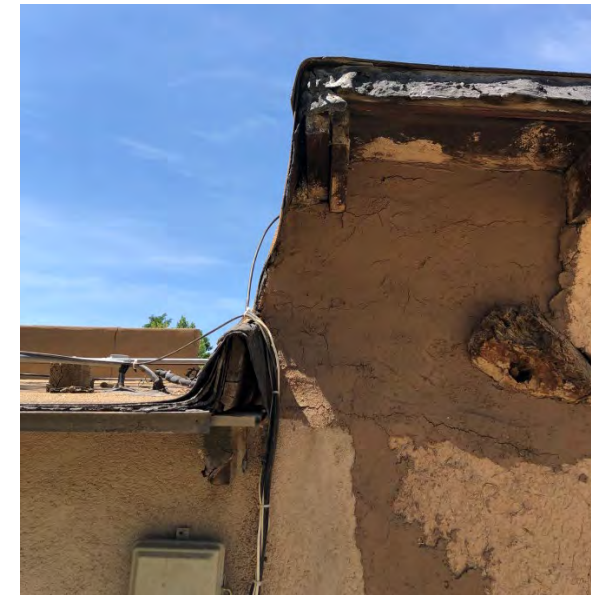
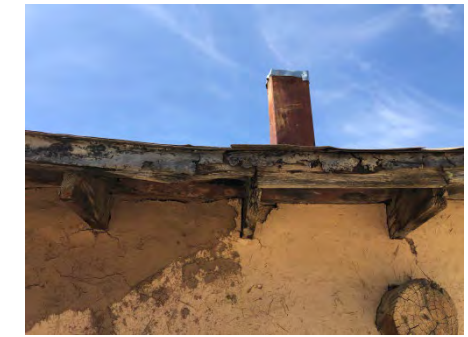
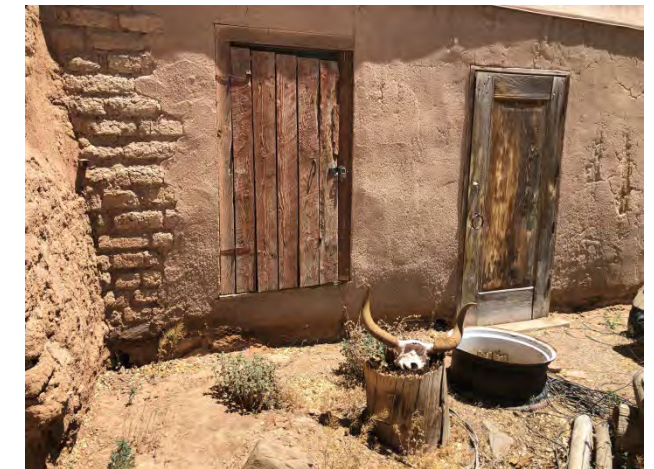
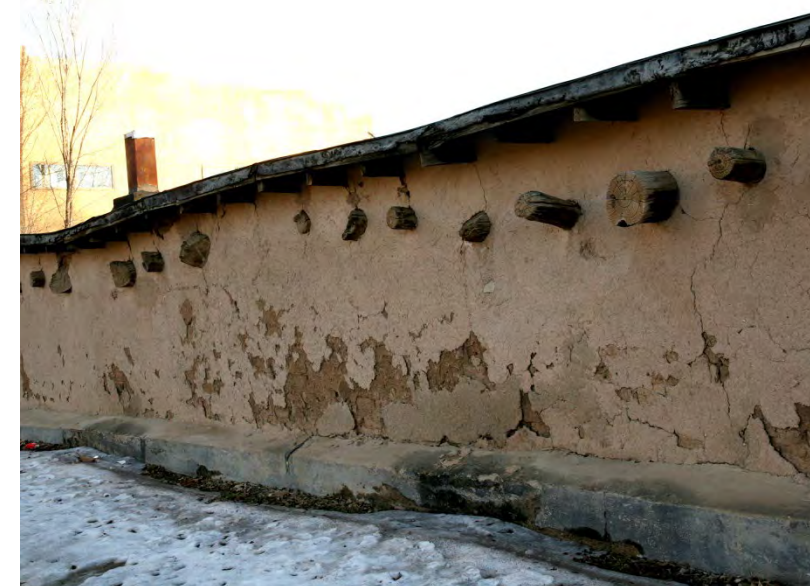
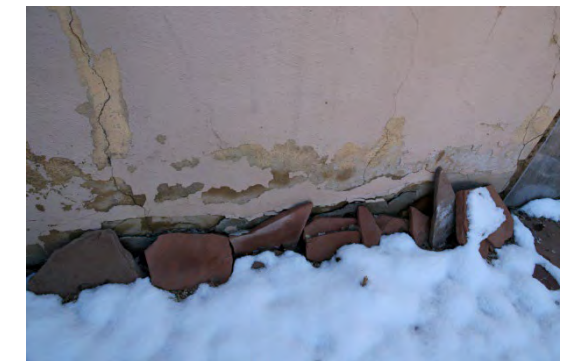
These images highlight just some of the concerns at the Carson and Romero Houses.
