KIT CARSON HOUSE

Taos, New Mexico

CURRENT CONDITION ASSESSMENT & PRESERVATION PLAN

Draft – September 16, 2022

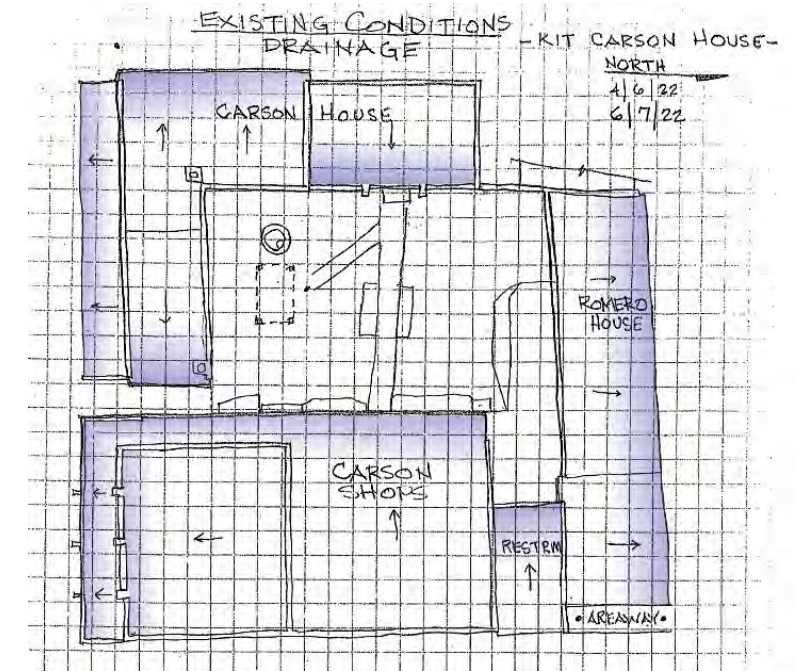
We found significant drainage issues in the central courtyard and around the perimeter of the buildings. In a number of areas, the exterior finish grade is higher than the interior finish floor.

There is considerable basal deterioration, with water not draining away from the walls. Also a concrete contra pared installed along the north side of Romero House is trapping water against the wall. Trees and other vegetation growing near structures are adding to the issues.

At right, a sketch showing roof drainage, tinted for emphasis.

Resolution of these issues will involve re-grading the site and the installation of drainage systems in the courtyard and elsewhere. The area north of Romero House is currently used for parking for Taos Inn, who will need to be involved with regrading and revision to the northern edge of the Kit Carson complex.

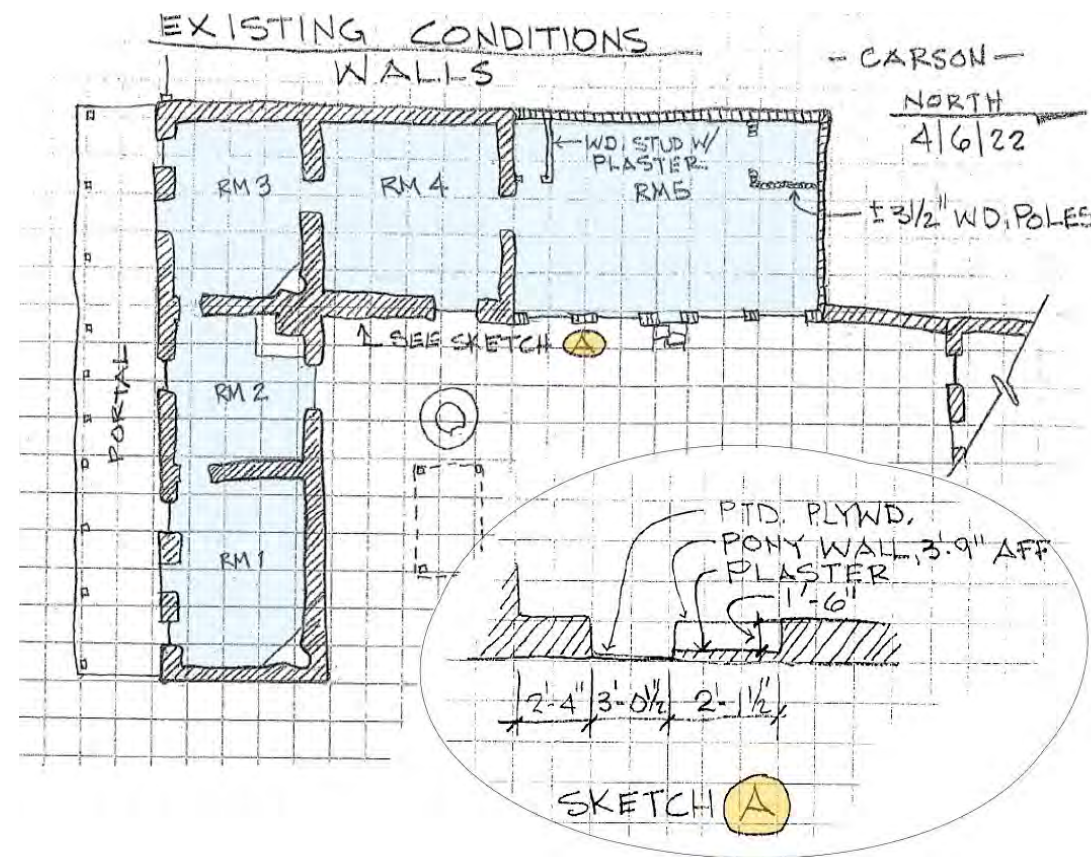
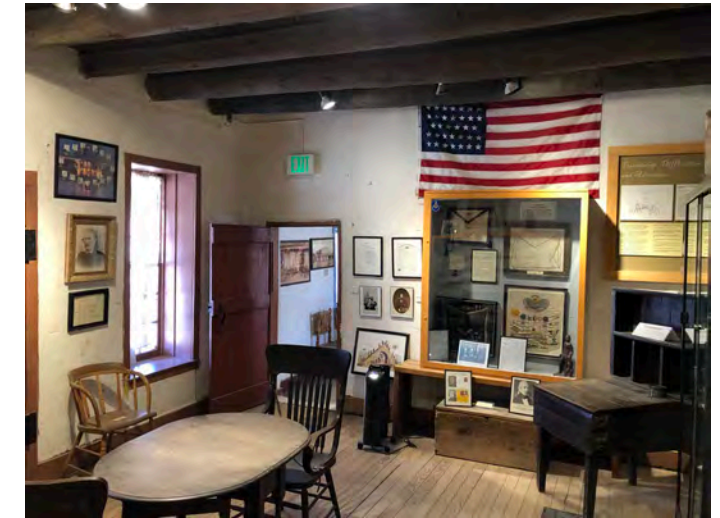
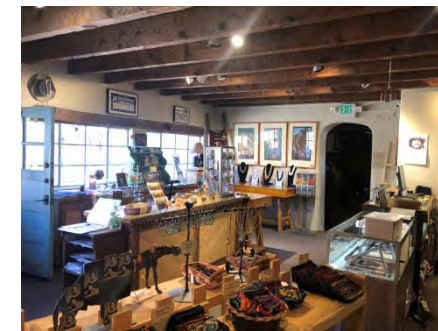
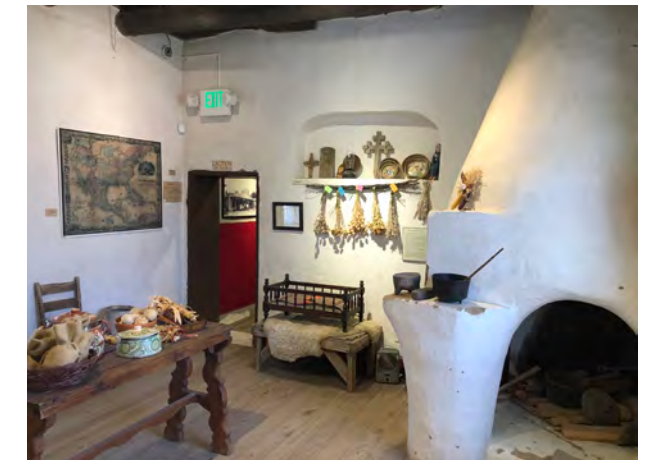
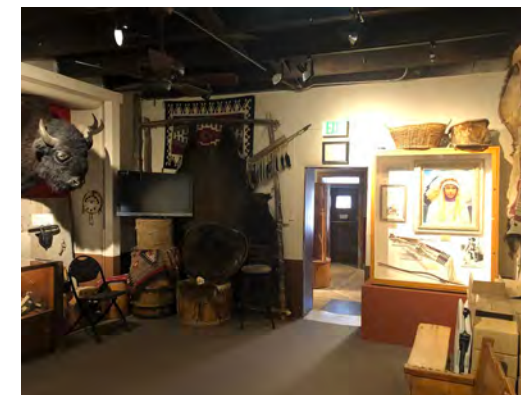
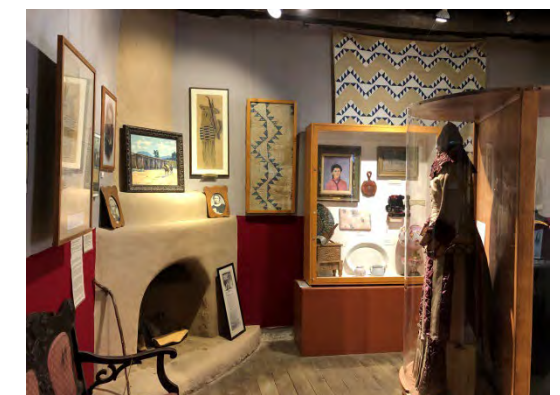
- All walls Rooms 1-4 are adobe approximately 20" thick except for interior wall between Room 1 and Room 2, which is about 11" thick.
- The walls of Room 5 (added in 1952) are approximately 9" thick and believed to be CMU.
- At Room 4, east wall at southeast corner near former door appears to have some CMU.
- Approximately north third of the west wall in Room 4 was reconstructed after collapse, around 2019.
- The base of the north walls at Rooms 1 and 2 and also the east wall at Room 4 are below finish exterior grade.
- Moisture observed in walls. Damage to base of walls observed due to wet/dry cycle, freeze/thaw cycle, and capillary rise. Water penetration at parapets present. Moisture stains observed at upper third of Room 3 west wall.
- Wood painted baseboard (1 x 6) in Rooms 1 and 2.
- Painted wainscot in Room 3.

Above left, sketch with field notes. Above, Room 1 of Carson House. Clockwise from below, Rooms 2 through 5.

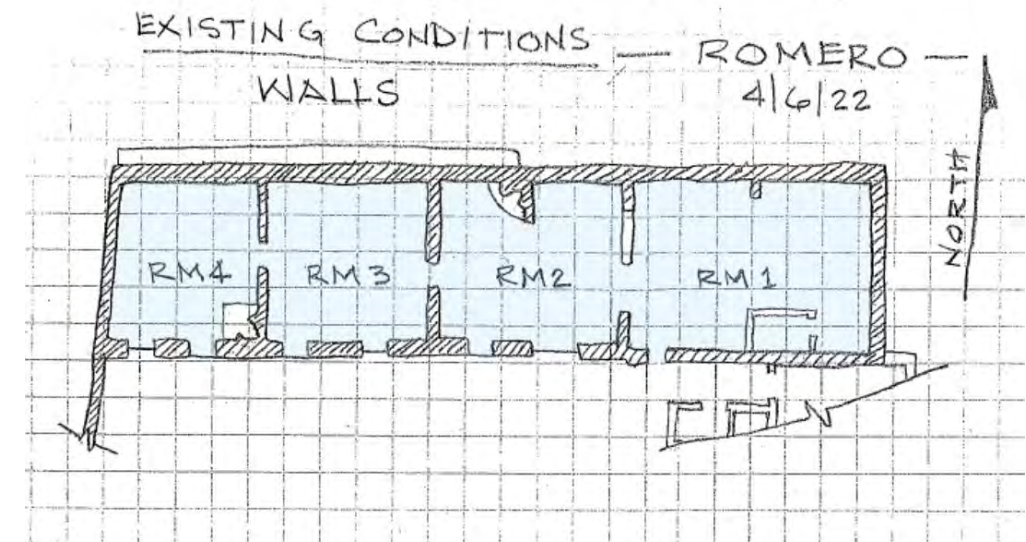
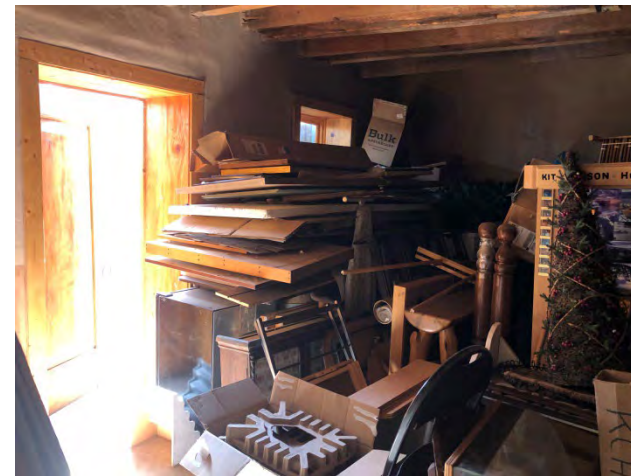
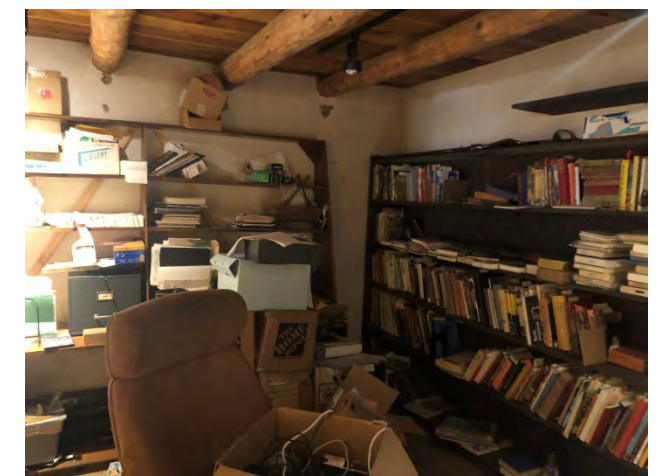
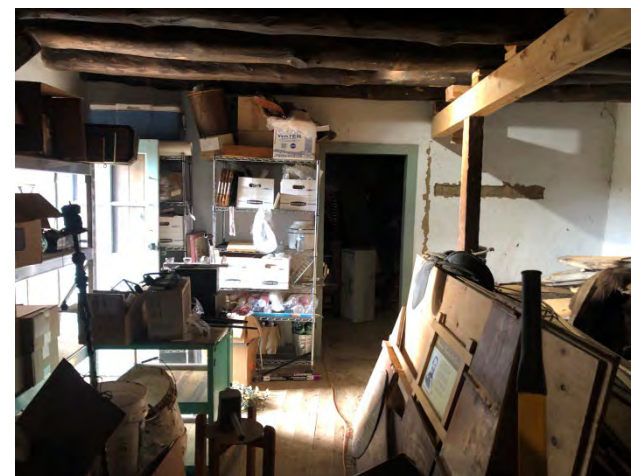
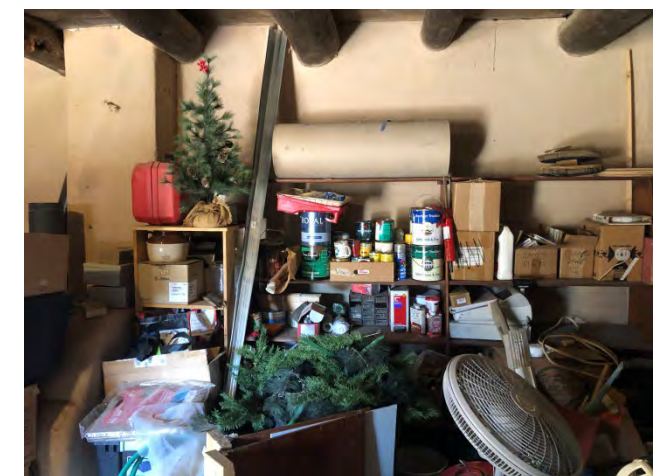
- Room 1 east wall and a portion of the south wall are CMU with cement stucco exterior finish, in fair condition. North wall is adobe with stucco exterior finish, which is in poor condition.

- Rooms 2 – 4 exterior walls are +/- 20" thick adobe walls with mud plaster finish in poor condition.
- Base of north wall, at Rooms 2 through 4, has a concrete contra pared and is below finish grade.

- Base of adobe walls exhibit extensive damage due to wet/dry cycle, freeze/thaw cycle, and capillary rise.
- At Room 1, restroom walls are 2x4 studs at 16" center to center with gypsum board on exterior face, and no finish at interior.

Additional access to interior of Romero House is needed to learn more. Additional investigation may need to wait until the actual preservation work is beginning. As the photographs reveal, the building is currently used for storage. A separate project for the Kit Carson House team will be clearing this out. It is certain that the current moisture levels do not make this an ideal storage space.

Above left, sketch of Romero House plan.
Clockwise from below right, Rooms 1 through 4.

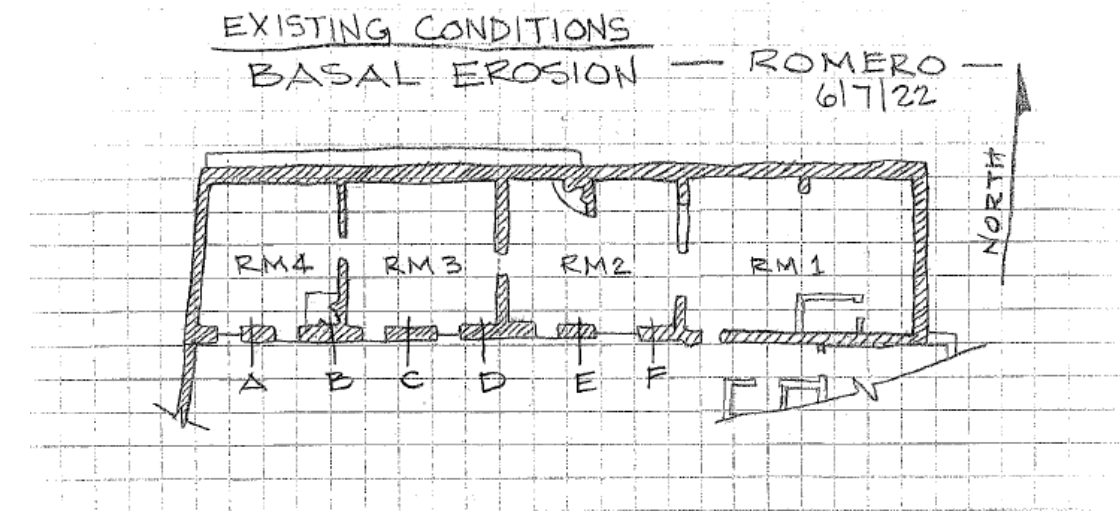
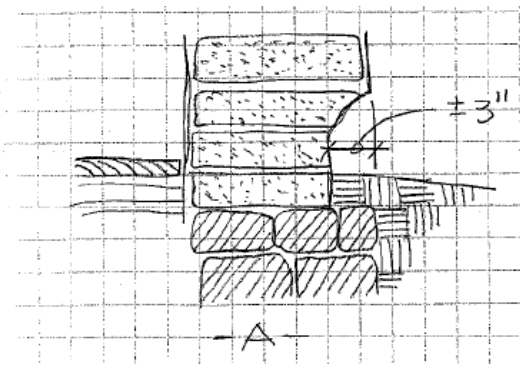
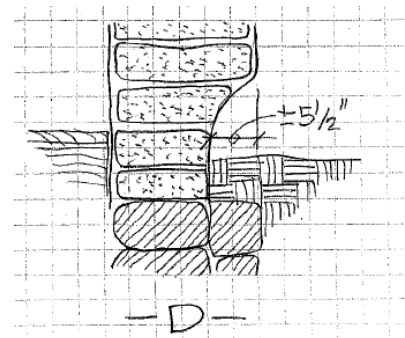
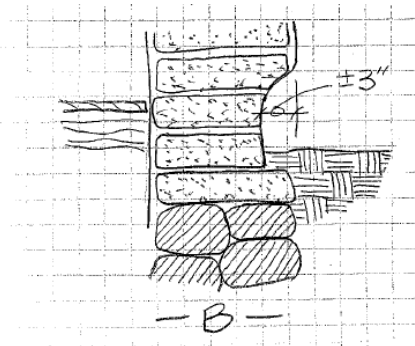
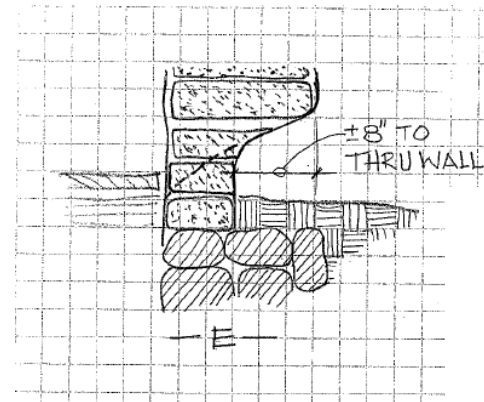
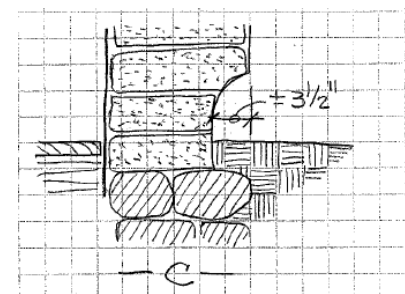
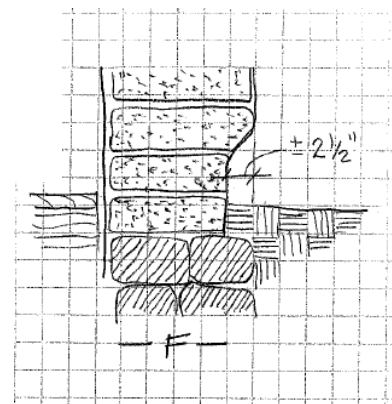
Measurements were taken at six locations along the courtyard wall of Romero House to evaluate the extent of basal erosion.

The sketched plan at right shows the locations. The sketches below illustrate the findings at each of these locations. This evaluation gives emphasis to the critical condition of this wall as a result of moisture.

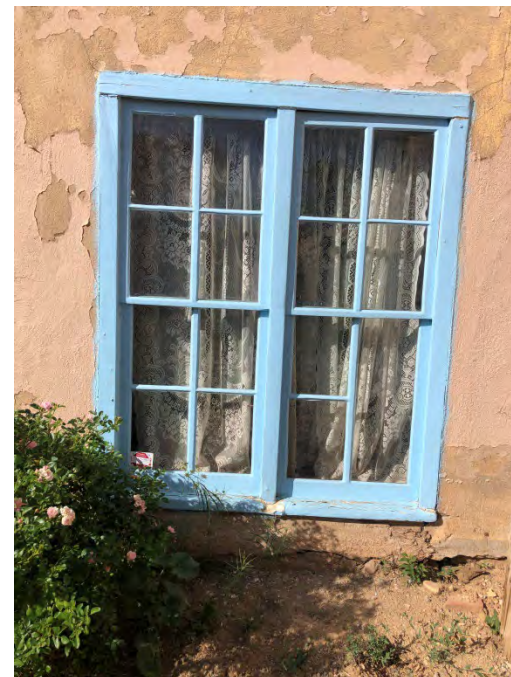
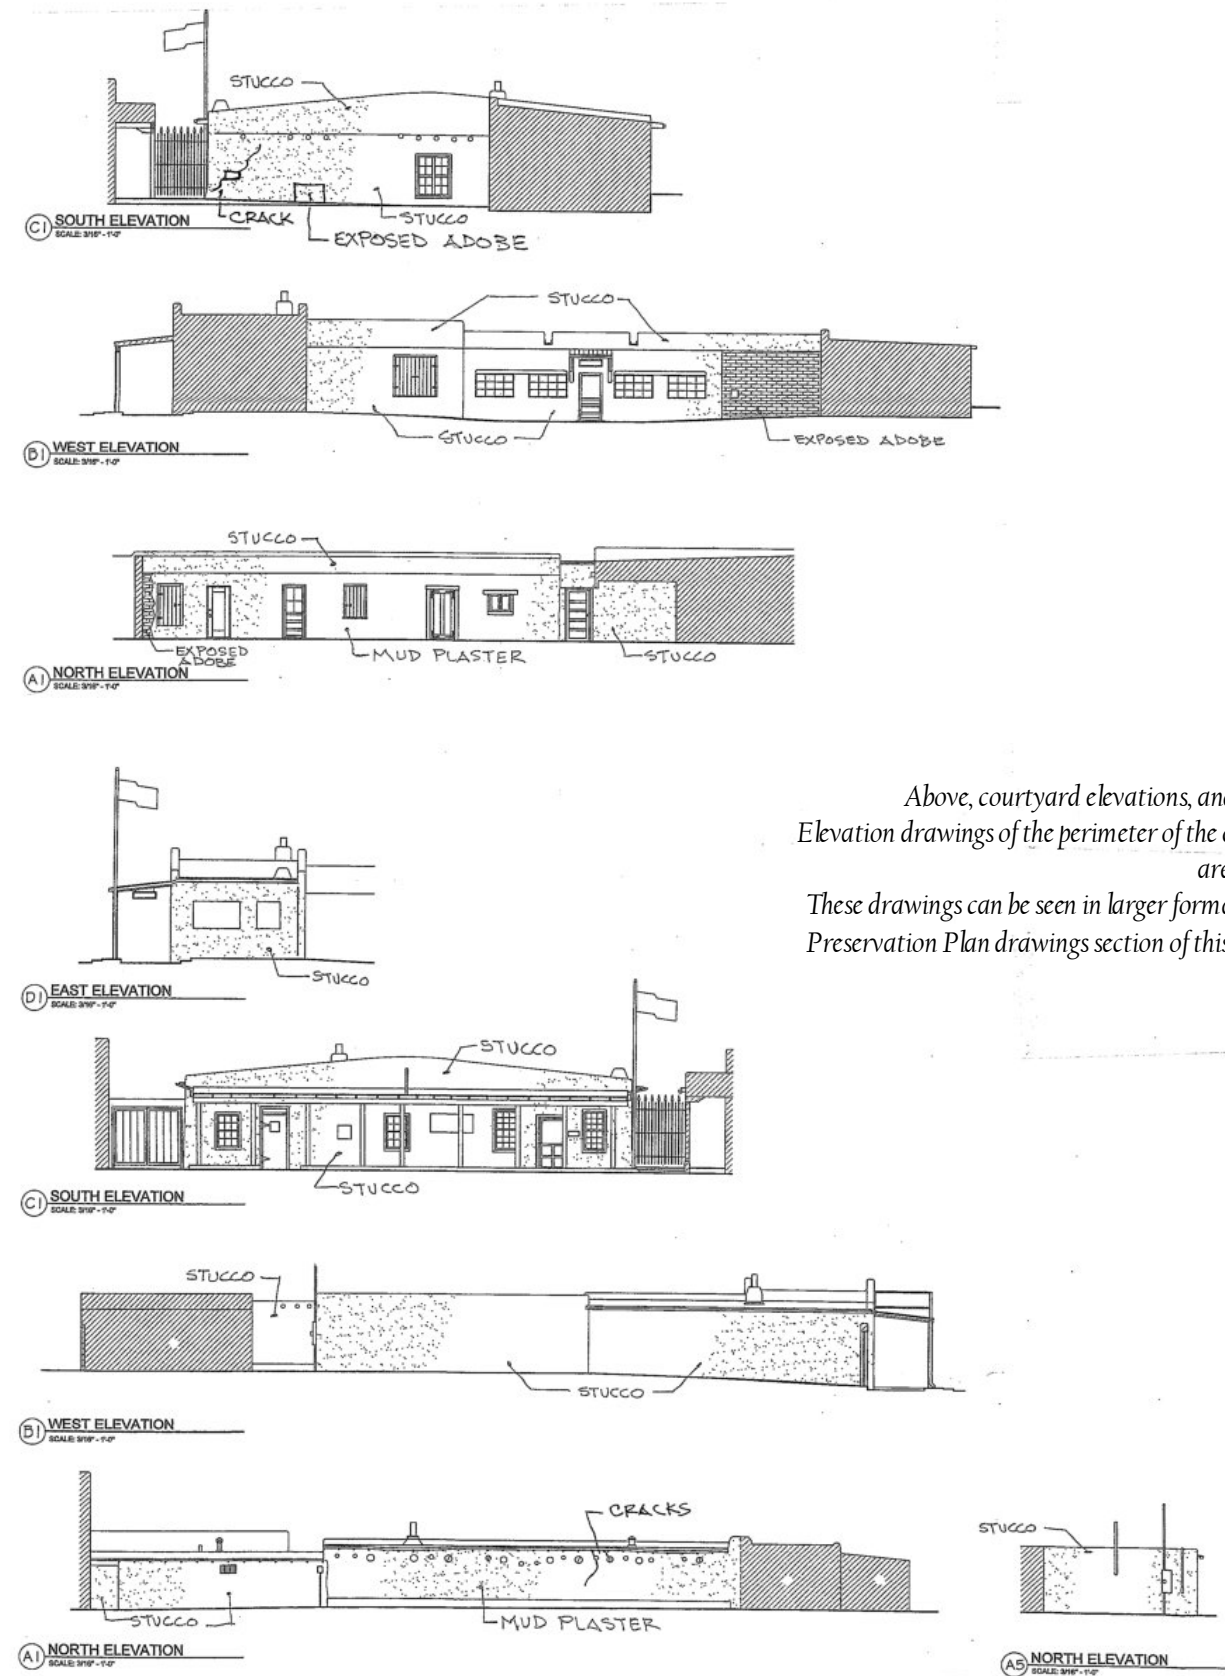
Above, courtyard elevations, and below, Elevation drawings of the perimeter of the complex are shown. These drawings can be seen in larger format in the Preservation Plan drawings section of this report.

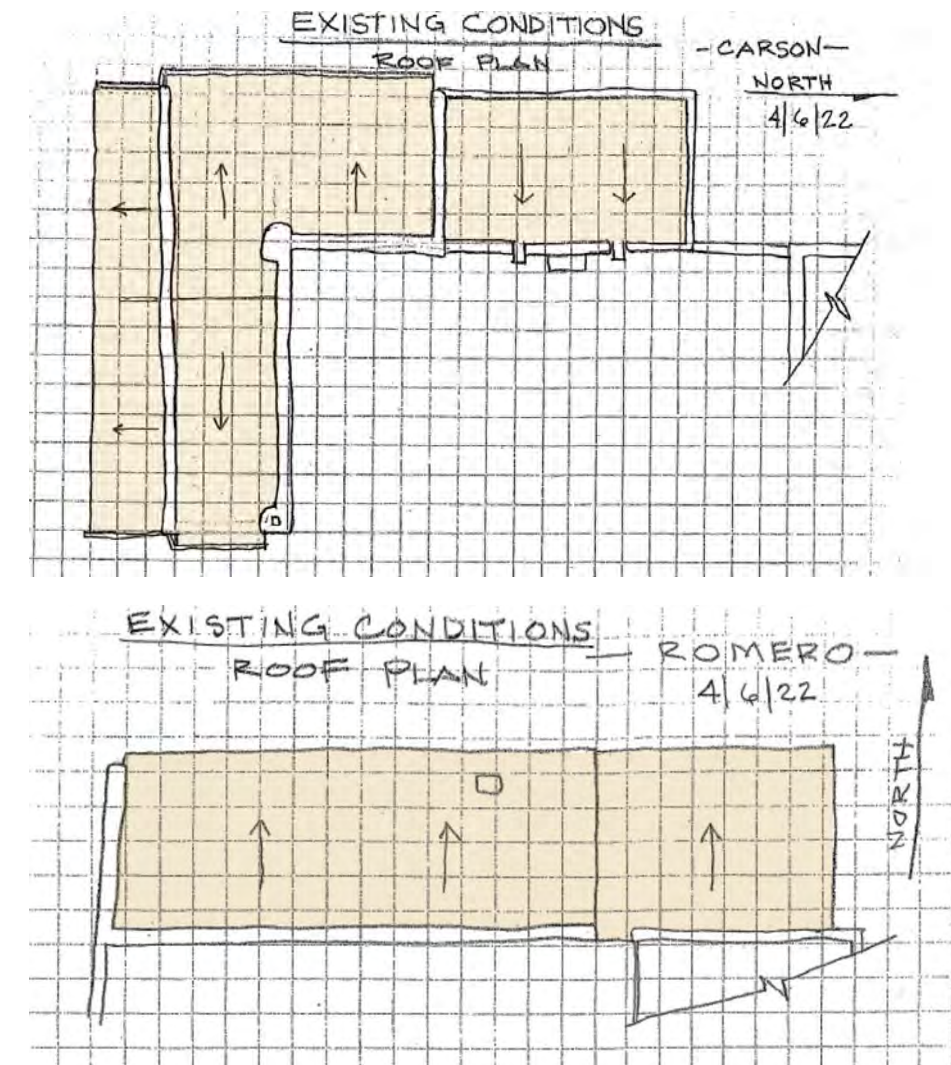
At the Carson House, the top layer roof is reported to be 27+/- years old, while the top layer at **parts** of the Romero House is reported to be 35 years old, though some new material installation **appears to** have been completed at the time the dirt was removed in 2005. At both houses, the roofing is past serviceable life, and must be removed and replaced. The Carson House gutters must be replaced. Romero House will need new gutters.

These aging roof systems, comprised of several generations of materials and construction in varying and largely unknown condition, no longer serve their structures reliably and certainly promote the risk of moisture entering both buildings. This report identifies the roof work as one of the highest priorities.

*Above right, field sketches of the existing roof installations at both buildings.
Below, photos show the diverse conditions of the aging roofs at both buildings. First three images are of Carson House.
Remaining two are at Romero House.*

This will involve removing all existing layers of roofing materials including the original dirt roof, which will immediately relieve the burden on the vigas, some of which are historic. Reconstruction of the roof will include structural repairs, and installation of empty conduits, ductwork, and other items in the roof cavity to minimize future disturbance within the roof during later phases of work on the buildings. Then a new roof system that is appropriate to the historic structure and that can protect the historic vigas and building below will be installed.

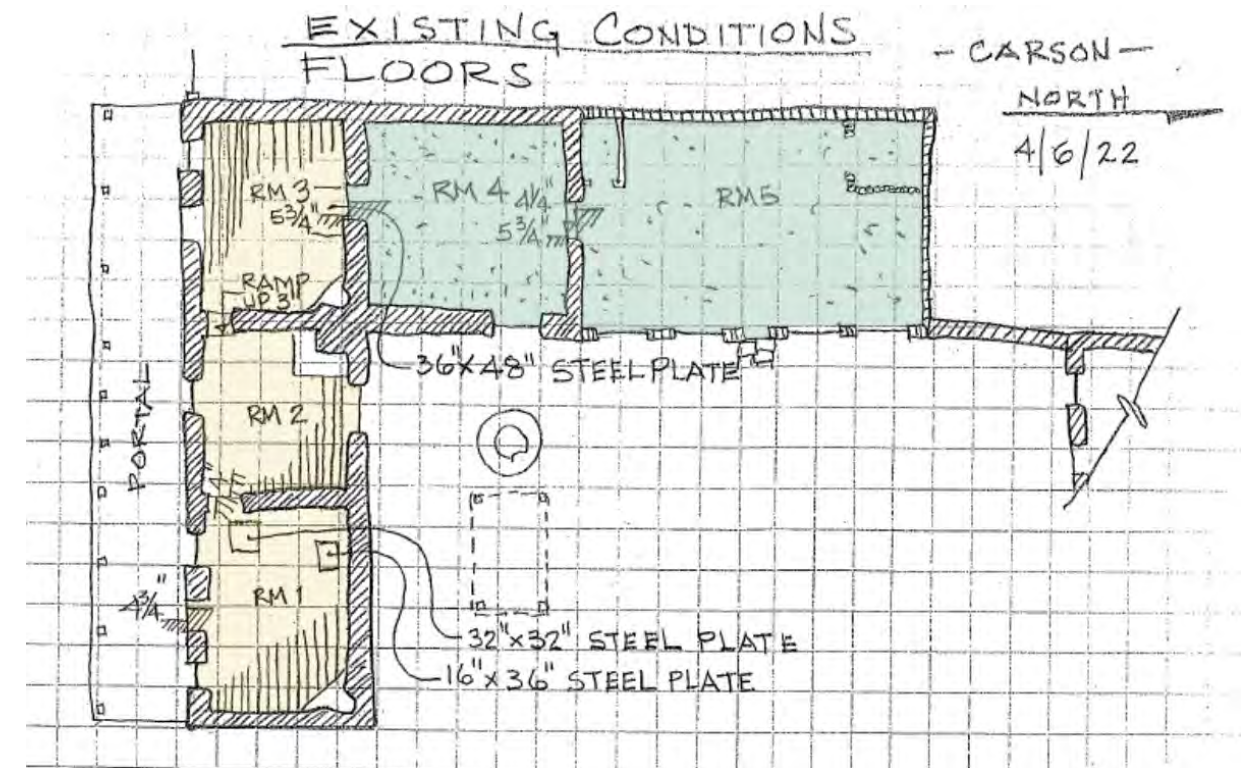
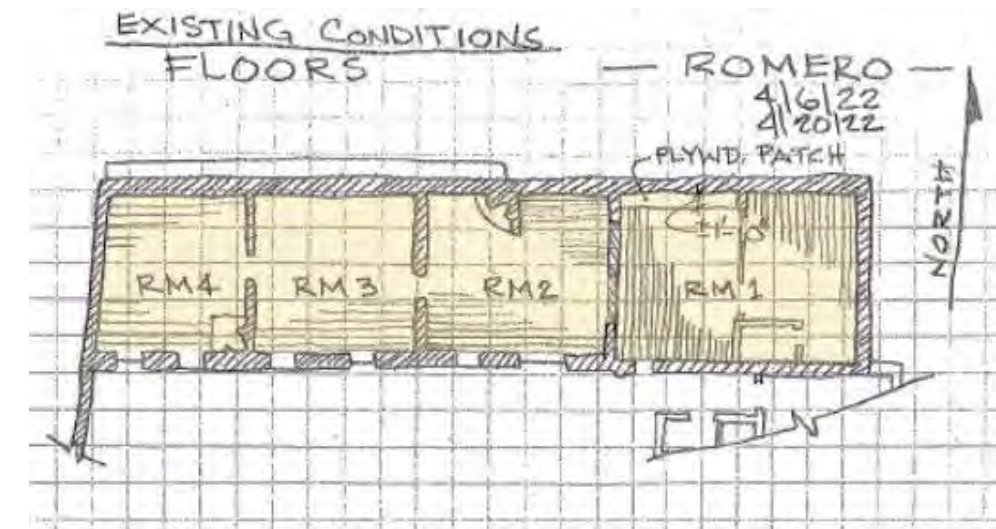
- The floor in Room 1 has 3 ¼" boards running east-west, probably fir, and is unfinished. This floor is attributed to the 1950's. There are two large steel plate patches on this floor.
- The floor in Room 2 has wider 5 ½" boards running east-west, also assumed to be fir, also unfinished. This floor is attributed to 1927.
- The floor in Room 3 is more complicated, with 3 ¼" boards over approximately the southern third of the room, and 5 ½" boards over the remainder. The wider boards are attributed to 1927. Both narrow and wide boards are assumed to be fir. The finish is worn off in this room. There are several sections cut out and patched, including with a steel plate, where wall shoring has been installed.

- At Room 1, the floor is comprised of 5 ½" tongue and groove boards running north-south, assumed to be fir, and stained. There are some soft spots.
- The floor in Room 2 has planks running east-west of assorted widths (3 ½", 5 ½", 7 ½"), thought to be pine. These are unfinished, and there are soft spots.
- The floor in Room 3 is 5 ½" wide tongue and groove, running east-west. Like Room 1, it is assumed to be fir, and there are soft spots.
- The floor in Room 4 is newer, with the floor and structure having been replaced around 1998. The floor is 7 ½" planks running east-west on 6x6 treated sleepers on the ground. The floor is unfinished and is thought to be pine.
- In general, floors appear to have settled in relationship to the baseboard.
- The crawl space in Room 1 by the restroom is +/-15" from finish floor to dirt. Further study needed.

Above, field sketches of the floors at both buildings.

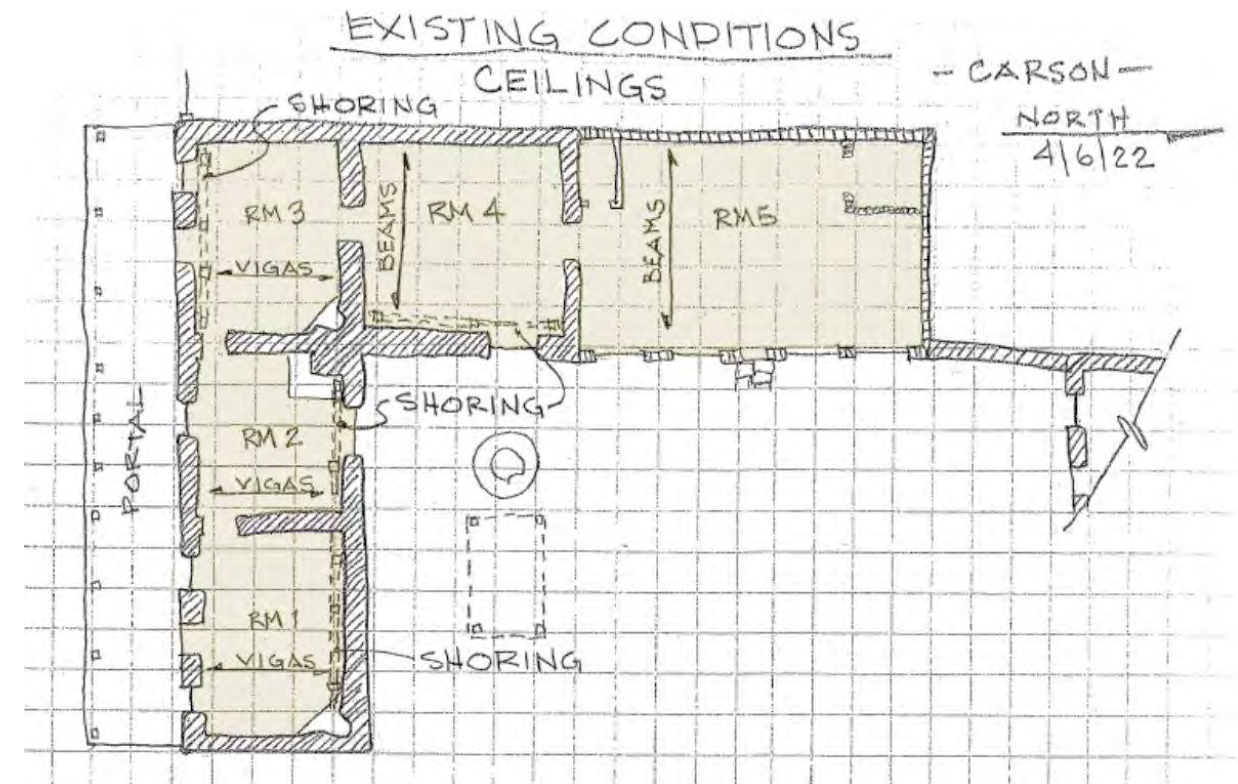
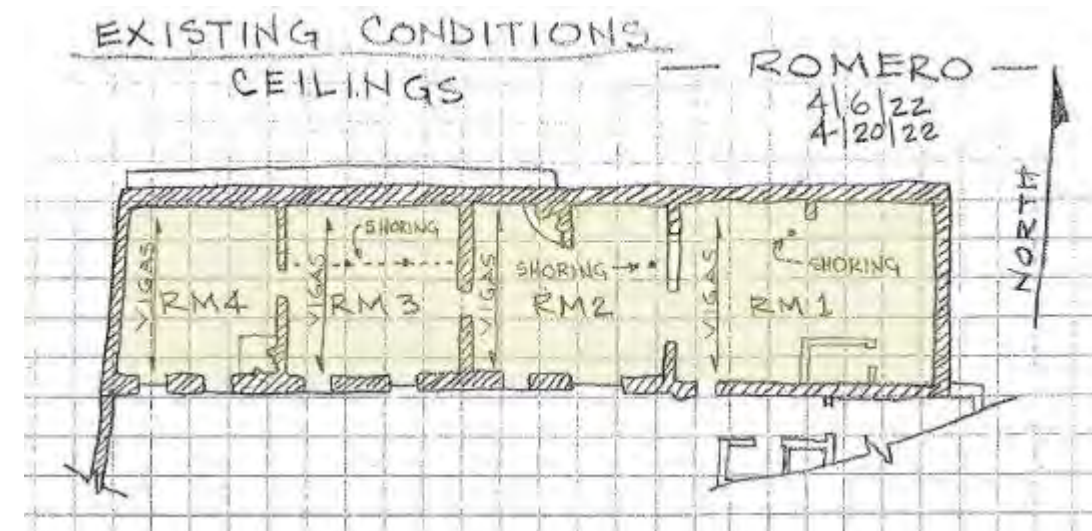
- Room 3 – Eight (8) 7” to 11½” diameter vigas at +/-2’-2” center to center. These vigas run north-south and are stained. +/-12” stained board ceiling running east-west. Ceiling height 8’-11” AFF at south wall center and 8’-8” AFF at north wall center. Shoring: two 4x6 posts with 8x12 horizontal located 2’-6” from north wall, centered.

- Room 4 – Seven (7) 7” to 10” diameter vigas at +/-2’-0” center to center. These vigas run north-south and are stained. 10” to 12” stained board ceiling running east-west. Ceiling height 9’-0” AFF at south wall center and 8’-11” AFF at north wall center. Also two (2) 2x6 or 2x8 sister joists at 5 vigas.

Above, field sketches of the ceilings at both buildings.

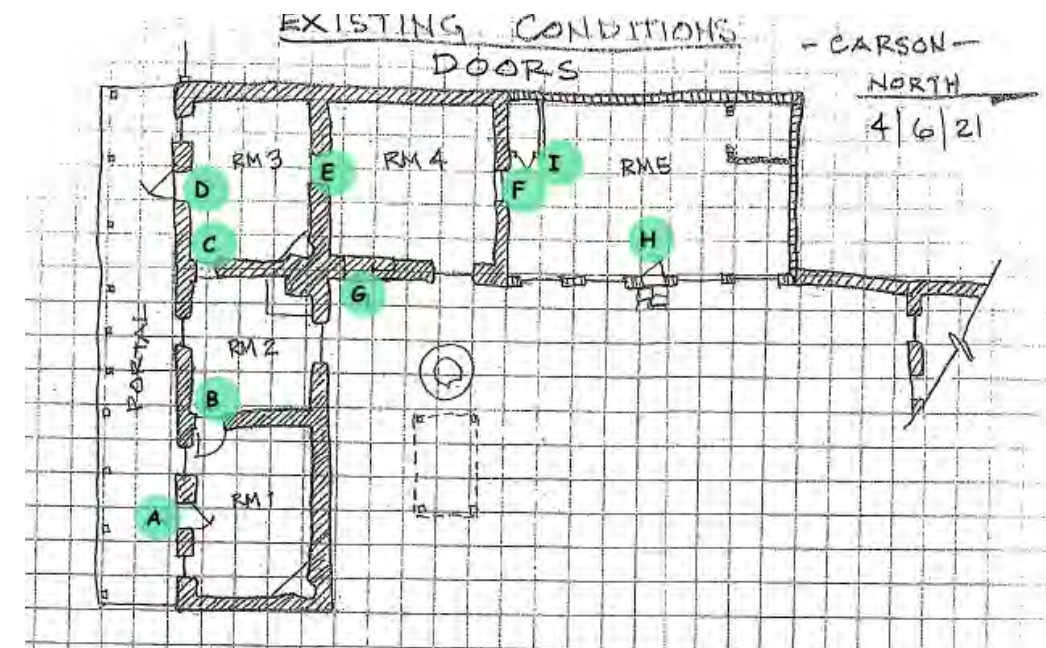
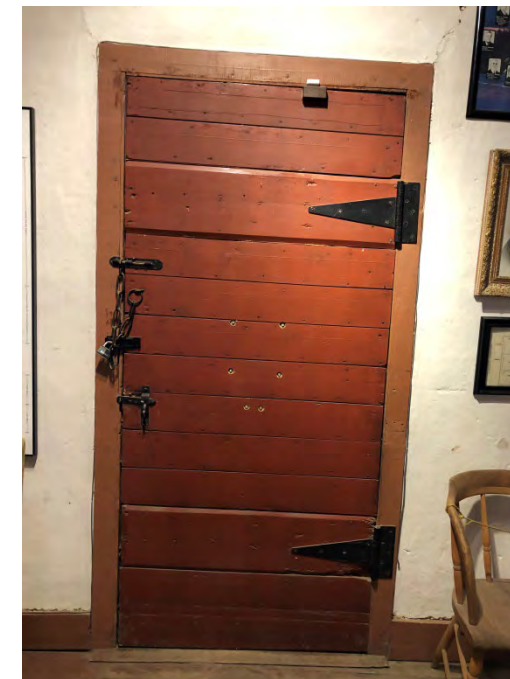
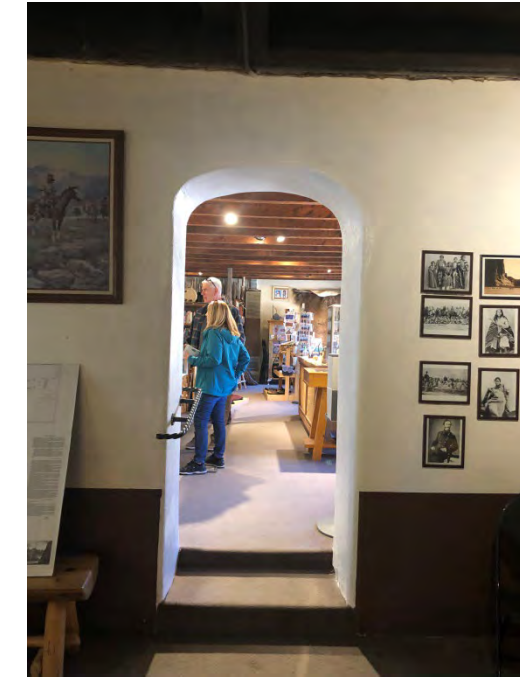
- Door G – 3'-1" x 6'-10", door has been sealed up with what appears to be painted plywood.
- Door H – 2'-11 1/2" x 6'-5" three-panel wood door with 2'-0" x 2'-3 1/2" light. Painted. Wood jamb, concrete threshold. Contemporary hardware passage set and two dead bolts. Screen door, stained, wood, with three bottom panels. No trim.

- Door I – 1'-11 1/2" x 6'-7" two-panel painted wood door, contemporary hardware, painted wood jamb, no threshold, no trim.

Top, door plan for Carson House.
Above, two of the doors in Carson House.

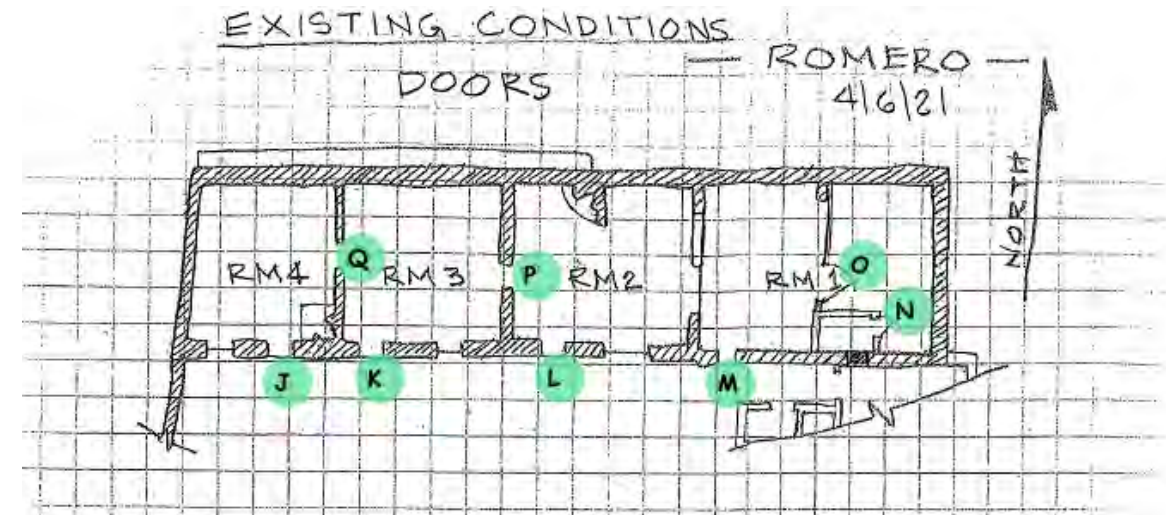
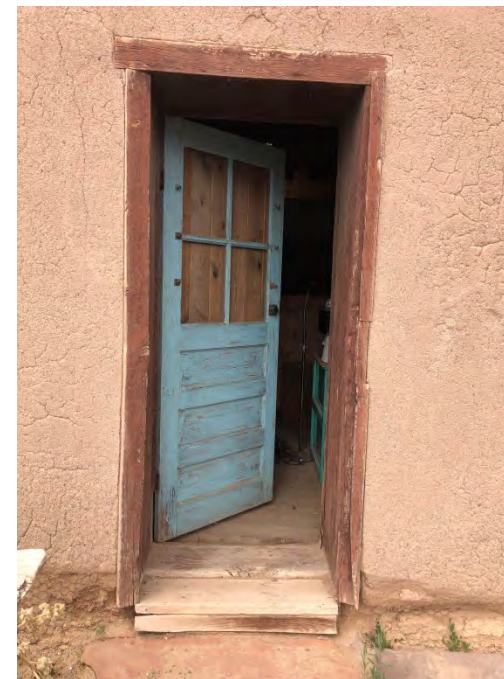
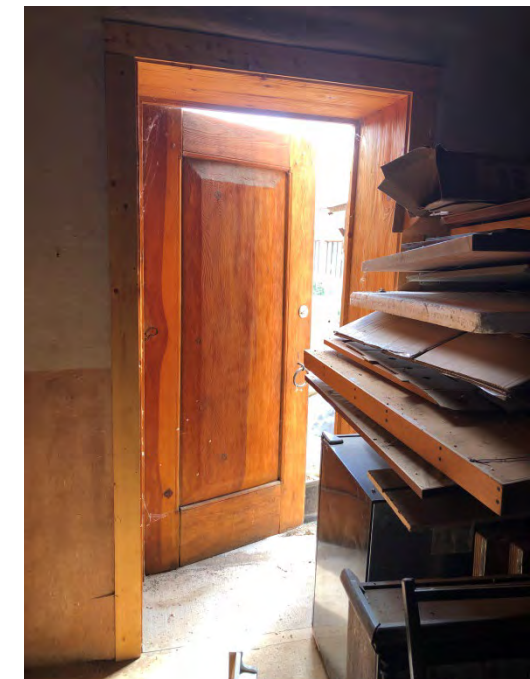
- Door P - Door opening 2'-6" x 6'-5", no door. Painted wood jamb, 1x4 painted trim, wood threshold.
- Door Q - Door opening 2'-6" x 6 1/2", no door. Painted jamb, 1x4 painted trim (Room 3 side), adzed (Room 4 side), no threshold.

- Possible former door location to exterior in restroom at Room 1.

Top, door plan for Romero House.
Above, two of the doors in Romero House.

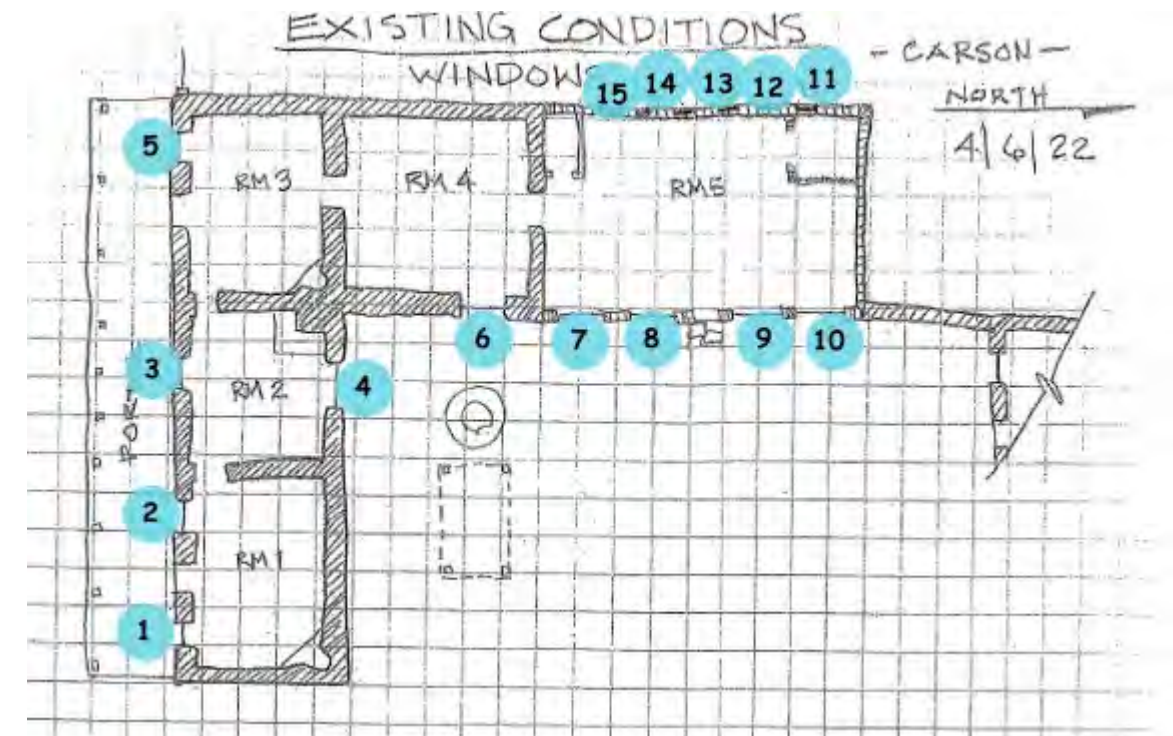
Windows appear to date from the 1911 through 1950's remodels. All windows need refurbishing.

- Window 1 - 2'-5" x 5'-6" 9-over-9 double-hung, painted, lx3 trim, thought to be from 1911. Sill 1'-10 1/2" AFF.
- Window 2 - 2'-5" x 5'-6 1/2" 9-over-9 double-hung, painted, lx3 trim, thought to be from 1911. Sill 1'-9 1/2" AFF.
- Window 3 - 2'-5" x 3'-11" 6-over-6 double-hung, painted, lx3 trim, thought to be from 1911. Sill 2'-4" AFF.
- Window 4 - Pair 2'-0 1/2" x 5'-1 1/2" 4-over-4 double-hung, painted, lx3 trim, thought to be from 1911. Sill 2'-9" AFF.
- Window 5 - 2'-4" x 3'-10 1/4" 6-over-6 double-hung, paint mostly removed from interior, lx3 trim, thought to be from 1911. Sill 2'-8" AFF.
- Window 6 - Steel casement, painted, plaster jamb, head, and sill, wood shutter on outside.
- Windows 7 through 10 - 3'-1 1/2" x 5'-8 1/2" 12-light steel casement, painted, plaster jamb, head, and sill.
- Windows 11 through 15 - former windows have been sealed over both inside and out.

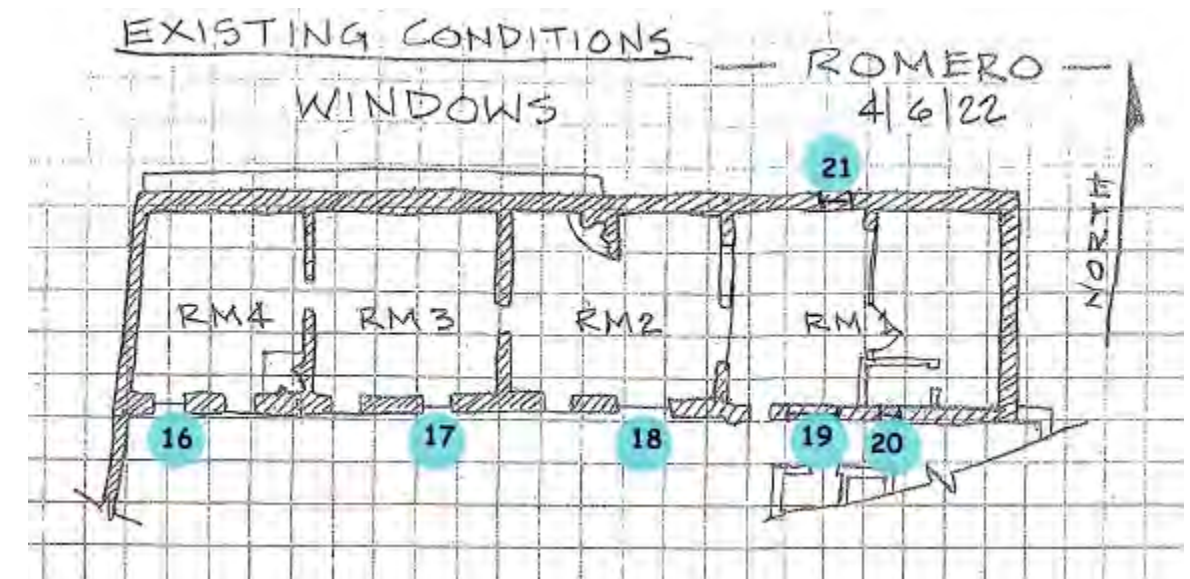
Romero House

- Window 16 - 2'-5 1/2" x 5'-1" 2-over-2 fixed sash, unpainted, lx4 unfinished trim, wood shutter, not painted. Window is in poor condition.
- Window 17 - 2'-5" x 4'-5 1/2" 2-over-2 double hung, painted, lx4 painted wood trim, wood shutter, not painted. Window is in poor condition.
- Window 18 - 5'-10" x 4'-7" window appears to have been removed, painted shelves inside, 2'-5" x 2'-2" unpainted wood shutter on outside.
- Window 19 - Former window location, no access, window was larger than unpainted wood shutter on the outside. Inside frame: 4'-5" x 4'-2 1/2".
- Window 20 - Possible former window location.
- Window 21 - Possible former window location at blocked grille location.

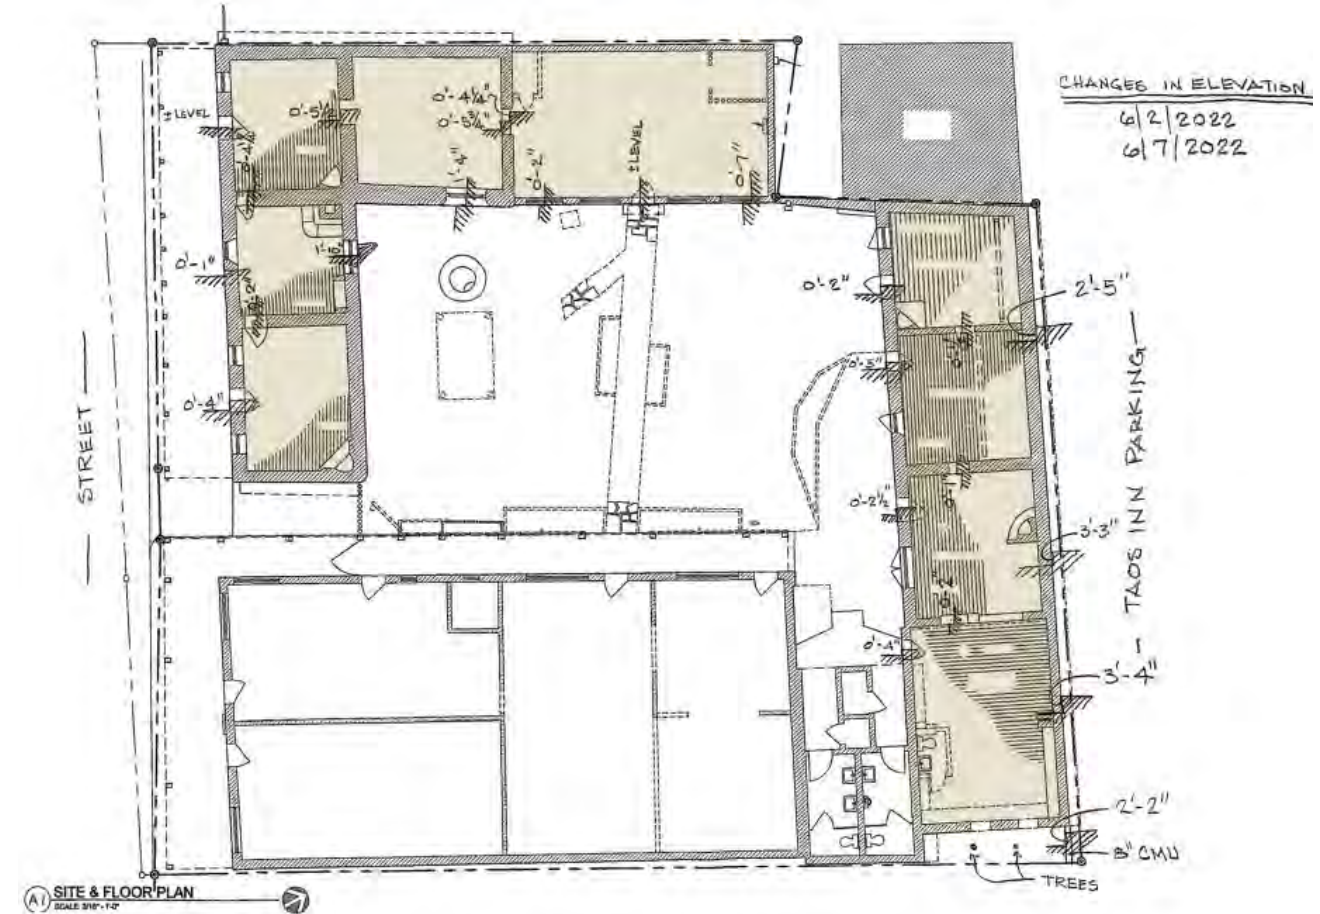
- There is an approximate 1" to 2" change in floor levels in Romero House.
- Abandoned restroom in Romero House is not accessible. Museum currently uses Town-constructed facilities.

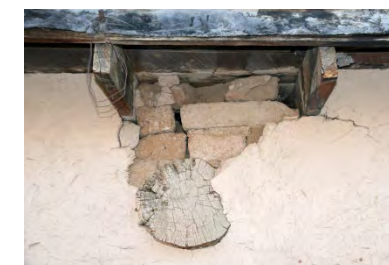
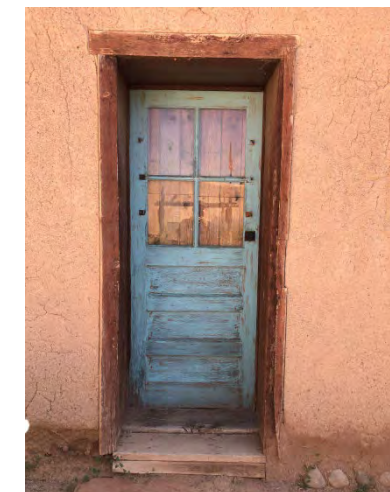
These images highlight just some of the concerns at the Carson and Romero Houses.
